Intel[®] Mobile Celeron[™] Processor at 466 MHz, 433 MHz, 400 MHz, 366 MHz, 333 MHz, 300 MHz, and 266 MHz Specification Update

Release Date: September 2000

Order Number: 244444-018

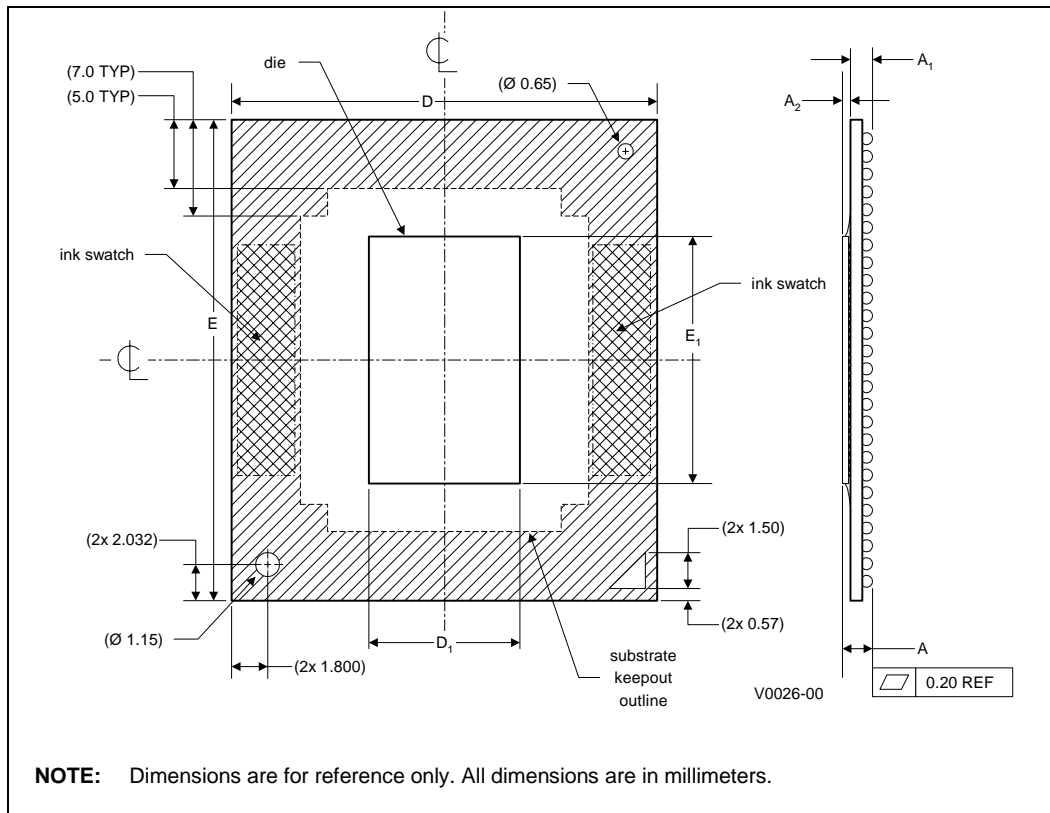
Figure 5.3. Surface-Mount BGA1 Package—Top and Side View

The following table and figures show the updated mechanical specifications for the BGA1 package, listed as Table 5.2, Figure 5.3 and 5.4, respectively, in the *Intel® Mobile Celeron™ Processor in BGA Package at 333 MHz, 300 MHz and 266 MHz* datasheet.

1. The number shown here is different from that in the 244444-004 version of this specification update. The maximum reference number is used.
